Delivering real CBM results in IoT4.0 for industry

Allan Findlow

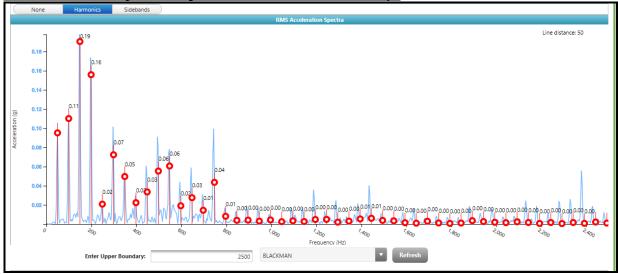
(Image no.10.)

Within the first month, both the client and DMS were receiving alerts (via e-mail) informing us that the white metal motor bearings were going into warning on both RMS acceleration and peak-to-peak acceleration. On investigation using the FFT spectral analysis we identified a form of rotational mechanical looseness at motor running speed which can be seen in the FFT screen shots below. DMS suggested to the end client that the suggested mechanical looseness was probably associated with significant wear on the white metal bearings and as a consequence should be investigated on an urgent basis.

Motor NDE bearing – FFT Spectra (Acceleration & Velocity)

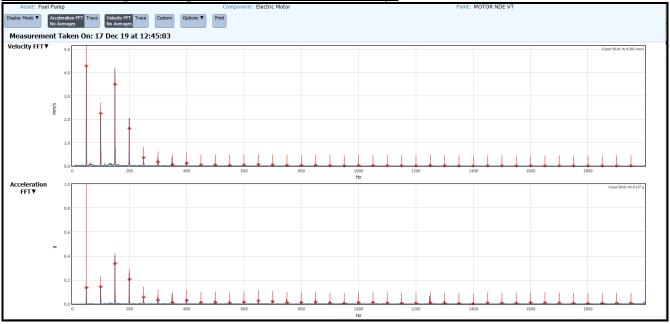
(Image no.14.)

Motor NDE bearing – FFT Spectra (Acceleration & Velocity)

We could see from the above FFT Spectral information recorded by our on site CBM engineer, that this information / data is similar if not identical to that recorded by our

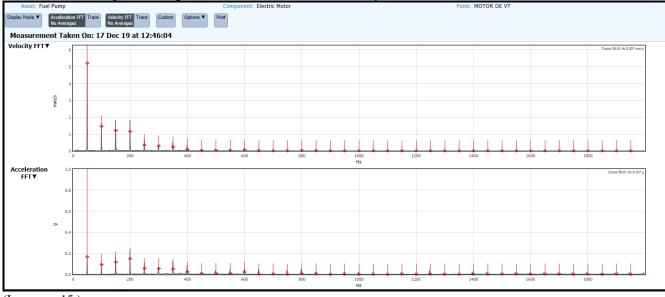
(Image no.15.)

Motor DE bearing – FFT Spectra (Acceleration & Velocity)

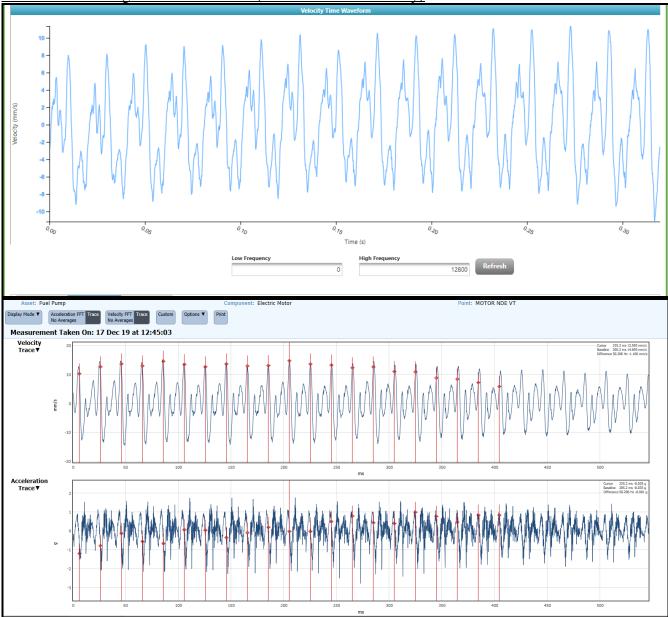
(Image no.16.)

We could also see the exact same pattern in both time waveforms which is a classic example of component looseness (see below).

Motor NDE bearing - Time Waveform (Acceleration & Velocity)

Based on the above confirmed data the client decided to remove the motor and pump assembly from service.
