Delivering real CBM results in IoT4.0 for industry

Allan Findlow

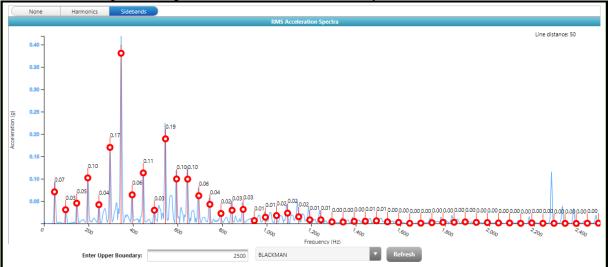
Within the first month, both the client and DMS were receiving alerts (via e-mail) informing us that the white metal motor bearings were going into warning on both RMS acceleration and peak-to-peak acceleration. On investigation using the FFT spectral analysis we identified a form of rotational mechanical looseness at motor running speed which can be seen in the FFT screen shots below. DMS suggested to the end client that the suggested mechanical looseness was probably associated with significant wear on the white metal bearings and as a consequence should be investigated on an urgent basis.

We could also see the exact same pattern in both time waveforms which is a classic example of component looseness (see below).

As mentioned in section 4 of this paper, the above complete pump and drive assembly was removed from site and delivered to an independent local engineering repair centre, who specialise in motor & pump overhauls.
